# COMMON ISSUES WITH 3-IN-ONE ABS AIR POWER LINES & HOW TO SOLVE THEM

## TROUBLESHOOTING YOUR 3-IN-ONE ABS AIR POWER LINES

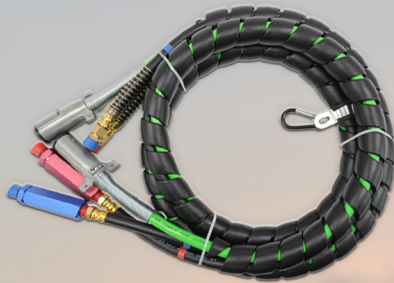
The most common issue is a failure of the Electrical Power Line. The connector has Seven (7) connection lines that conduct electricity. If just one of the connectors become defective, the entire power chord will cease to function properly. Over time they can become loose due to wear and tear, road hazards, and even sharp turns.
